METAL ROOF RESTORATION

Restore and Cool Roofs.

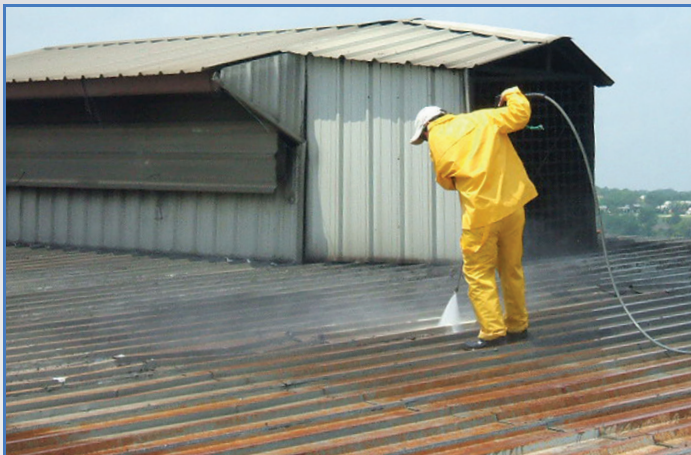
Prepare the roof. Prep and clean the roof, removing dirt and debris.

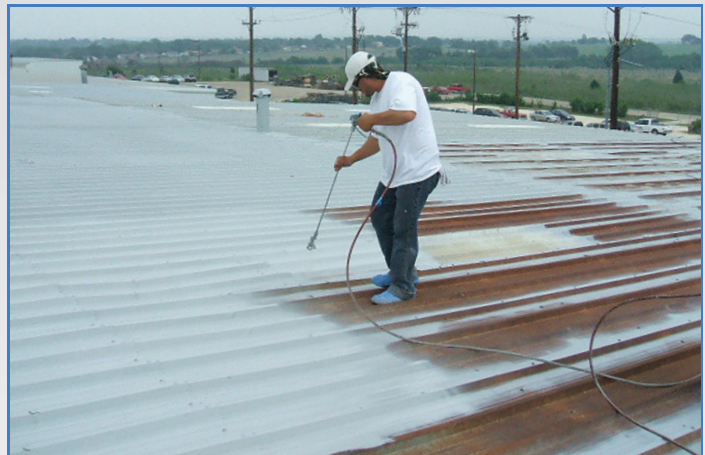
Prime all rust with **ERSystems Acrylic Metal Rust Primer** or **Polyurethane Metal Rust Primer**.

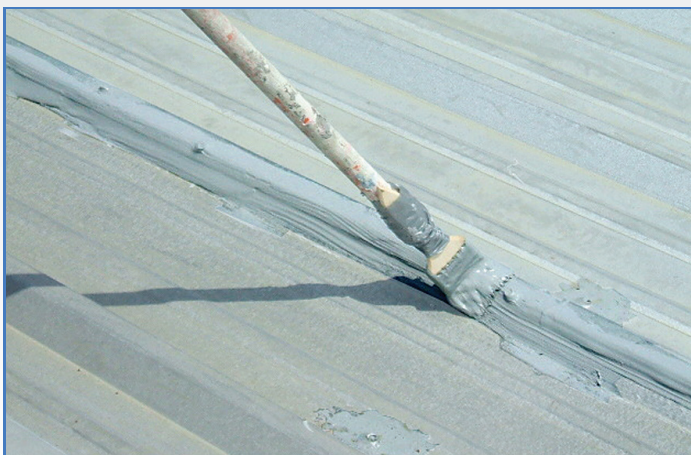
HER Polyurethane Sealant is applied to the seams, fasteners and penetrations and then smoothed with a brush.

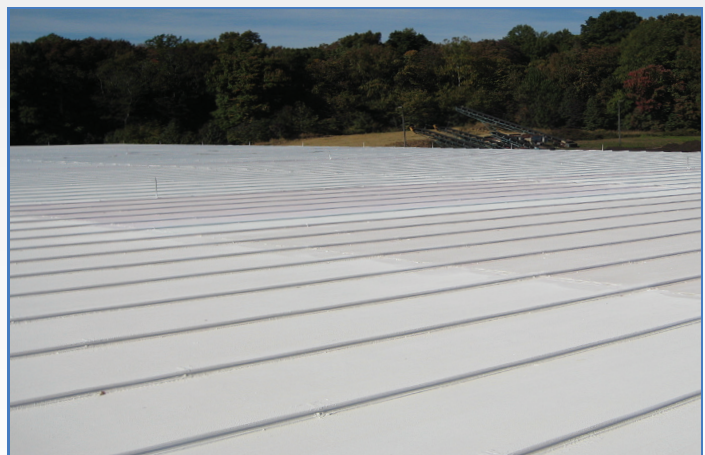
Apply 2 coats of **ERSystems Acrylic 1000/SW** or **Polyurethane 300 Finish Coat**.
